A chronology of rapid, emergency bridge repair.

Seven days in June

A problem at a Denver & Rio Grande Western bridge at Minturn, Colorado. The structure is on the D&RGW mainline from Kansas City to Salt Lake City. A large section of the concrete bridge pier No. 2 has been discovered to have a severe crack in it. The separated segment has also shifted slightly, being retained only by some of its steel reinforcement.

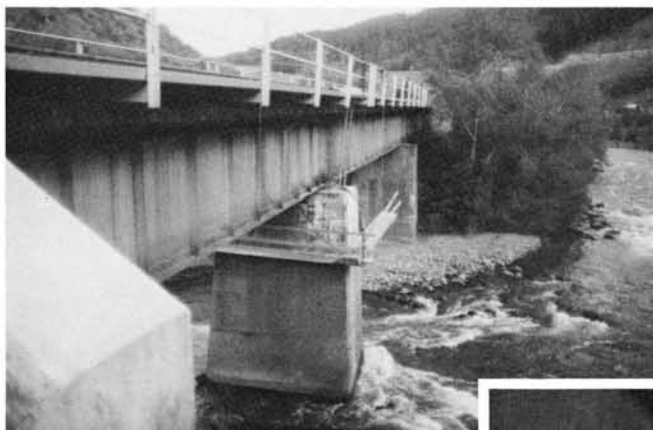
In spots, the separation is as much as 2-inches wide. Alarming, the crack runs directly under the south bridge bearing area of the pier, leaving only about 30 percent of sound support for the bearing plate. The divorced section has slipped down about ½ inch and the bearing is tipping slightly. Action's needed, and quickly! The clock is running...

Problem on D&RGW bridge in Colorado: severe split in its second pier.

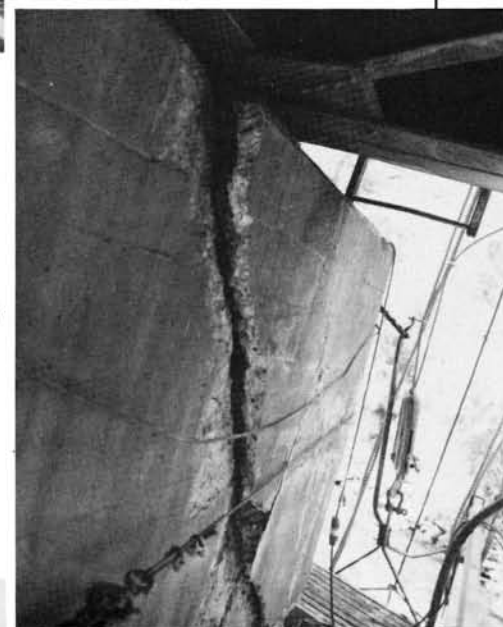
Cable stays keep loose concrete segment from displacing further during work.

DAY 4—Osmose repair crew and equipment arrives. They and D&RGW team get right to work. The loose section has to be kept from displacing even more during repair. Steel cables are wrapped around the pier, holding the divorced segment firmly. The crack is cleaned; deteriorated and loose concrete removed...

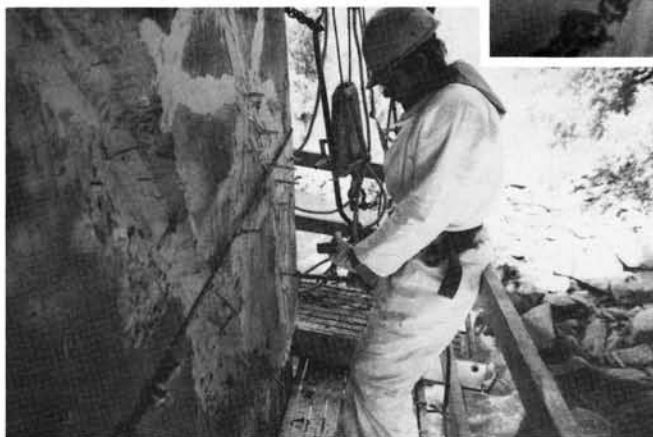
Osmose technician injecting epoxy formulations to 'weld' crack shut.

Besides the main crack, there are several smaller fracture branches. All are sealed with an epoxy paste. The sealant cures rapidly, and the main crack is next filled with an epoxy/sand compound—'welding' the crack shut. But more needs to be done to assure the structural integrity of the pier support.

DAY 5—Work begins immediately with the injection to refusal of a special liquid epoxy formula into the crack system and any other voids. Next, at critical locations, 1½-inch
